LIGHT HOUSINGS FOR DEEP-SUBMERGENCE

APPLICATIONS—PART III. GLASS PIPES WITH

CONICAL FLANGED ENDS

Technical Report R-618

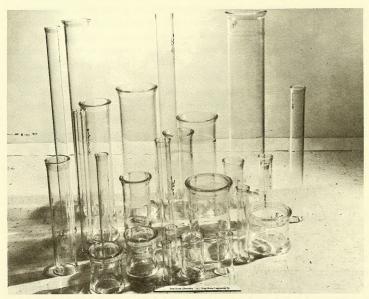
Figure 1. A sampling of the variety of glass pipe diameters and lengths tested in this program.

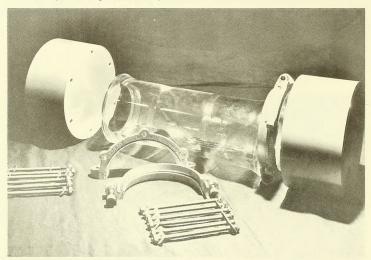
Figure 2. Component parts for a short-term critical pressure test assembly.

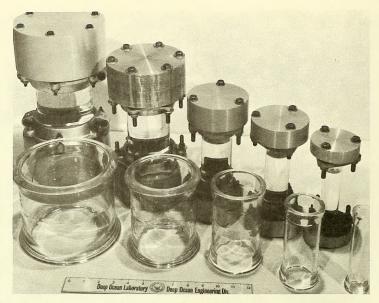
Figure 4. Six-inch-long glass pipe test assemblies made up with 1-, 2-, 3-, 4-, and 6-inch-ID pipes.

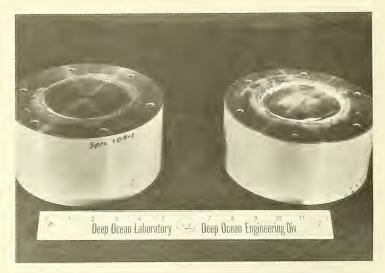
Figure 6. Damage to aluminum end-closure plates resulting from the implosion of a 4-inch-ID, 6-inch-long glass pipe at 16,900 psi,

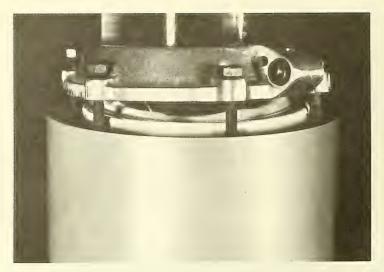
Figure 9. Appearance of glass-to-metal contact area and RTV silicone rubber seal before the tie bolts were torqued.

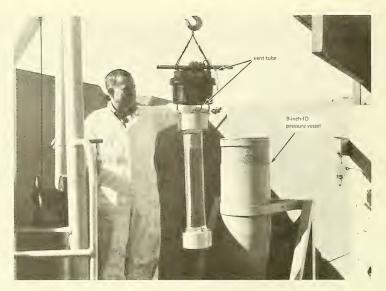
Figure 13. Typical water-filled specimen assembly showing connection through the end closure to the pressure vessel head and the atmosphere.

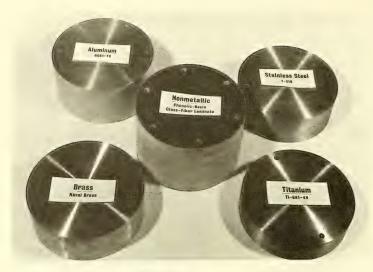
Figure 16. Typical end closures used to evaluate the effect of end-closure material on short-term critical pressure of 4-inch-ID x 6-inch-long glass pipe with flanged ends.

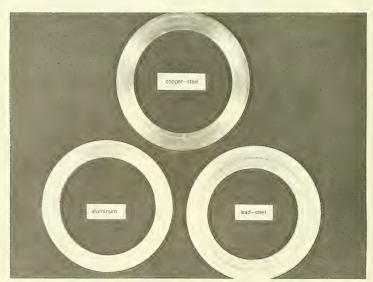
Figure 23. Aluminum, composite copper—steel, and composite lead—steel washers showing the relative depth of indentation resulting from pressurization of experimental sealing and bearing system assemblies to one cycle at 3,000 psi external hydrostatic pressure.

propagated up into the pipe wall. While this system very likely is satisfactory for cyclical service at some pressure less than 3,000 psi, it was not tested at lower pressures and its maximum useful depth rating is not known.

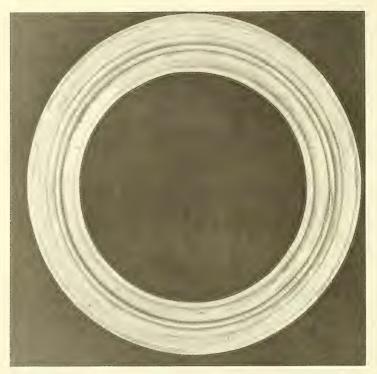
While the lead bearing system provided the most "compliant" of the glass-to-metal bearing systems (see Figure 25), it did not produce the desired critical pressure for the system. All specimens tested failed during the first cycle to 3,000 psi. While this system very likely is satisfactory for cyclical service at some pressure less than 3,000 psi, it was not tested at lower pressure, and its maximum useful depth range is not known.

Figure 25. Composite lead—steel washer following external pressurization of test assembly to 3,000 psi. The lead has plastically conformed to the configuration of the glass pipe end flange and its integral O-ring groove.

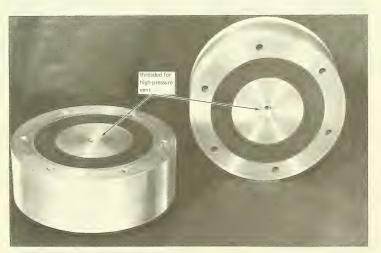
Figure 31. End-closure plates used in testing the Vespel and the neoprene washers (shown here). The high-pressure vent is utilized in the experimental measurement of internal volume change and for attenuation of implosion force.

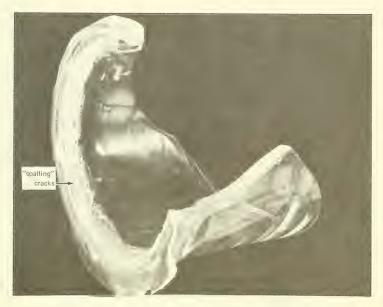
The actual cracks observed in specimens appear to be of three general types. *First* the cracking and subsequent spalling of very thin shards in the area where the inside rim of the pipe contacts the end plate (Figure 37). *Second* are the concentric shear cracks propagating from the pipe surface in contact with the end closure (Figure 38). These cracks, in most cases, result in the cracking off of the portion of the pipe flange which is greater in outside diameter than the main section of the pipe, and thus unsupported. They appear to be a result of a combination of the shearing of the glass pipe flange

Figure 37. Typical example of the cracking and spalling occurring in a 4-inch-ID x 6-inch-long glass pipe with aluminum end-closure plates externally pressurized to 20,000 psi.

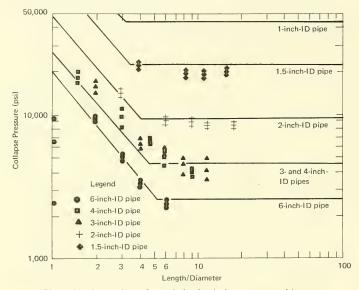
Comparison of experimentally determined implosion values with the calculated curves for the same t/D ratio discloses rather good agreement between them. The agreement becomes more remarkable when it is noted that there are so many dimensional variations in the pipes and the flanges at the end of the pipes do not represent the simple supports specified by the analytical expression. Only one pipe size, the 6-inch-ID  $\times$  6-inch-long pipe, imploded at pressures significantly lower than the calculated pressure.

Characteristically, this is also the only pipe configuration tested where the distribution of cracks was distinctly different from those in other pipe configurations. In the  $6 \times 6$ -inch pipe configuration, all of the cracks were radial oriented along longitudinal axis of the pipe, while in other pipe configurations they were mostly of the circumferential type. It would thus appear that because of the low L/D ratio for the  $6 \times 6$ -inch pipe configuration, the stress distribution is such that failure occurs at lower hydrostatic pressure due to failure of material initiated by stress raisers on the bearing surfaces rather than at the higher pressure predicted for it by elastic buckling theory.

Figure 41. Comparison of actual pipe implosion pressures with pressures calculated on the basis of Equations 2 and 3.
